PILOT ADVISORY

Cessna seat malfunction

A recent product liability trial stemming from the crash of a 1966 Cessna 172G has highlighted apparent flaws in the design of seats and seat-latching mechanisms in single-engine Cessnas.

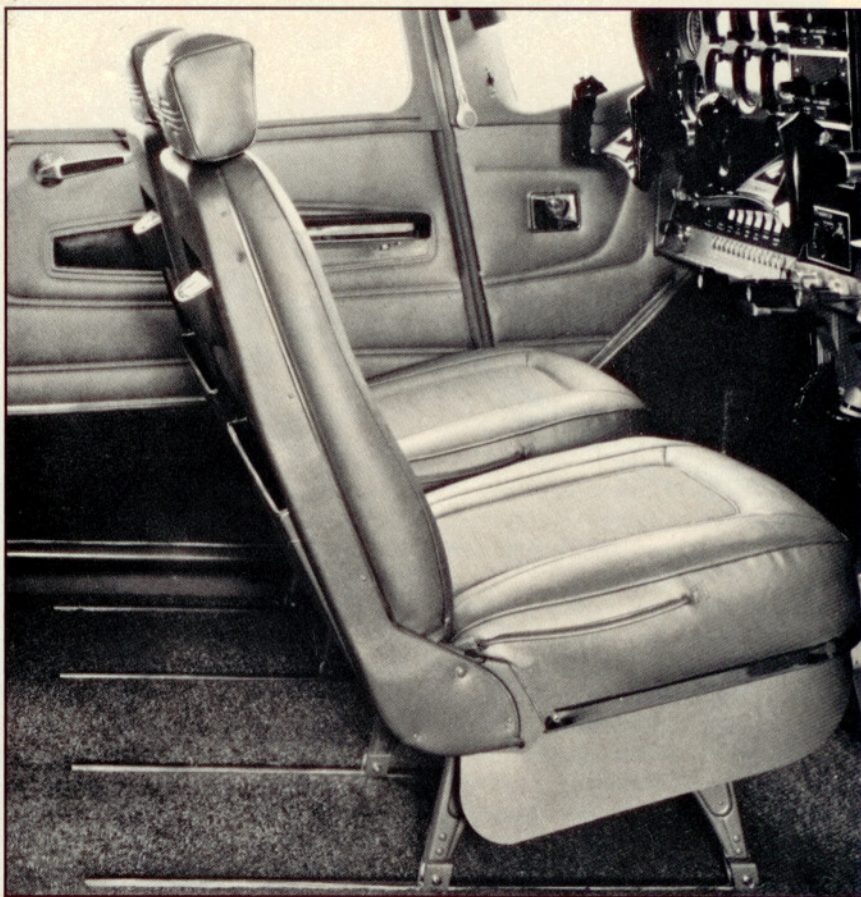
Interior shot of 1969 Skylane shows one reason for seat track wear: seats must slide forward for rear passengers to enter, aft for front occupants.

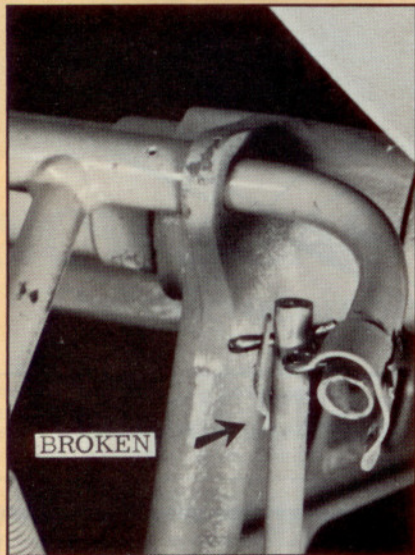
Failed connection between actuating arm and linkage to latch pins.

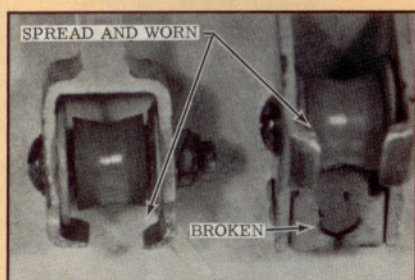
Spread roller housing lets seat sway sideways and rock up and down. Slop could cause pin to unlatch.

The worst case of wear we found was in a 1977 Cessna 172 that had seen heavy use as a trainer. In this airplane, the seat could be swayed from side to side, so that only one latching pin would align with the holes in the track. Furthermore, the aluminum flanges that hold the seat to the track had opened to such an extent that the flanges on one side could be lifted over the track when the seat was rocked from side to side. However, as long as one pin was engaged, we could not jerk the seat loose from the latched position.

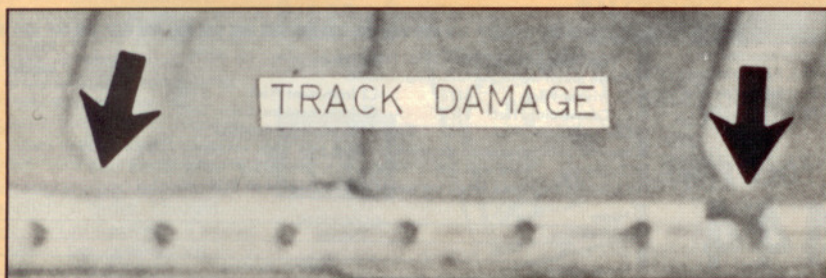
Repeated fore and aft seat movement chews up track. Note scoring where seat latching pin has carved a groove in the track.

Judging by the number of complaints involving gouging of the lock pin holes, excessive clearance between the track rails and the seat rollers, and the occasional case of the seat slipping rearward on takeoff, these areas are not getting as much attention as they should be. Dust and debris accumulations on the seat rails contribute to the problem. So can overweight pilots. Since we can do little about the latter, we suggest improved cockpit cleanliness, a close check at each inspection, and replacement of parts when necessary. It might prevent an accident, or at least an embarrassing incident.

NOTE: The following was recently received from a mechanic via a Malfunction or Defect Report: "The seat stop is forcefully rammed into the top of the seat rails each time the seat is moved backwards. Eventually, the rail is grooved and then cracks. This process can be retarded by gluing a small piece of hard rubber channel to the underside of the stop. The rubber from a MS21919 DG clamp works very well."

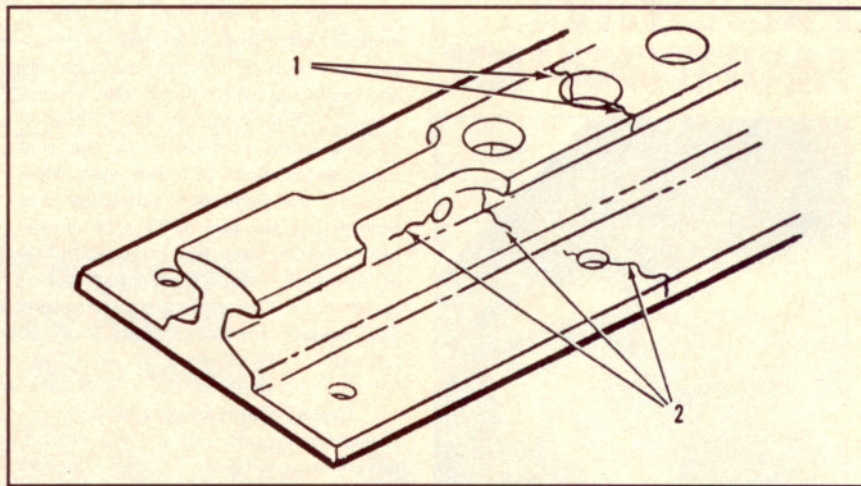
Illustration from Cessna 207 manual. Number 1: Track usable if crack not closer than one inch to similar crack. Number 2: Track unusable.
