Farewell, ripped and beaten seats— Hello, fresh leather and bubinga wood

BY THOMAS A. HORNE

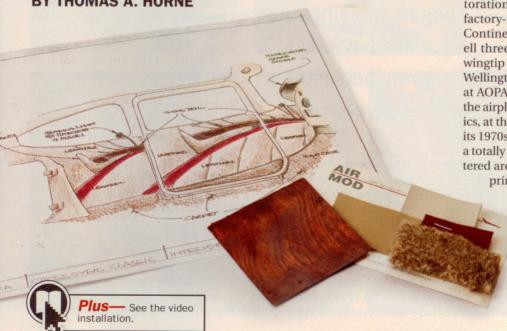
t's been a mere seven months since we first bought AOPA's 2011 sweepstakes Lairplane—a tattered-looking 1974 Cessna 182P-and put it through several major-league steps in its complete restoration. First came the installation of a factory-remanufactured, 300-horsepower Continental IO-550 engine, a new Hartzell three-blade propeller, and Flint Aero wingtip fuel tanks at Air Plains Services of Wellington, Kansas. After a stint on display at AOPA Aviation Summit in Long Beach, the airplane next went to Advantage Avionics, at the Chino, California, airport. There, its 1970s-chic panel was yanked in favor of a totally new design. The new panel is centered around Garmin's G500 combination

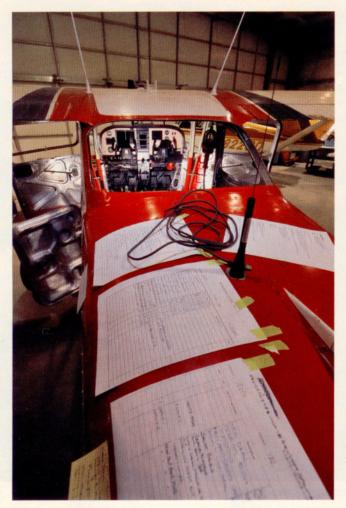
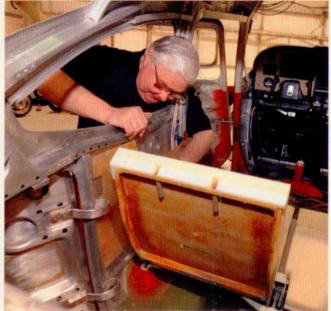
A job this big calls for lots of paperwork (far left). Air Mod's Dennis Wolter (above) puts the final touches on a soundproofing insert. New fiberglass wing tips were installed (left).

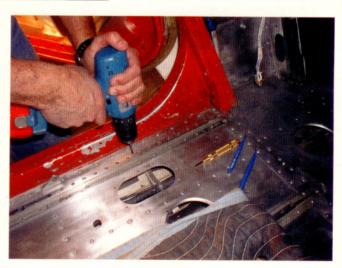
The old seat covering material was yanked (left) while new leather-covered interior door panels were installed to the door inserts (below). Cracked fuel-line connections at the wing roots (bottom left) were replaced with new rubber sleeves. New seat rails from MacFarlane Aviation Inc. were installed (bottom right) to prevent seat slips.

Air Mod's attention to detail took other avenues. The nosewheel assembly, for example, was found to be loose and in need of new bushings. The nosewheel itself—a three-piece assembly—had allowed moisture into the bearings over the years, and you know what that means. Yep, corrosion. So a new, modern-style, two-piece nosewheel was ordered and installed. Air Mod also installed the sleek new Knots2U wheel pants, Hartwig Fuel Cell Repair's Monarch fuel caps, and new seat rails from MacFarlane Aviation Inc. of Baldwin City, Kansas (www.macfarlane-aviation.com).

As for the seat rails, they're the subject of a repetitive airworthiness directive that calls for inspections every 100 hours. The holes in the rails are engagement points for the pins that lock the front seats in place. If the holes are elongated, the seat can slip during takeoff or other times when flying at nose-high attitudes. This sort of seat slippage has been blamed for fatal accidents, but installing new seat rails does away with both the AD and the danger. So new seat rails also made sense in our goal to make this sweepstakes airplane the best it could be. Anyone flying an older Cessna single would be well-advised to keep an eye on those seat-rail holes, and replace the rails at the first signs of wear-even if a set of seat rails can set you back some \$600.
