Midair Collisions Analyzed

by LEW TOWNSEND/AOPA 376636

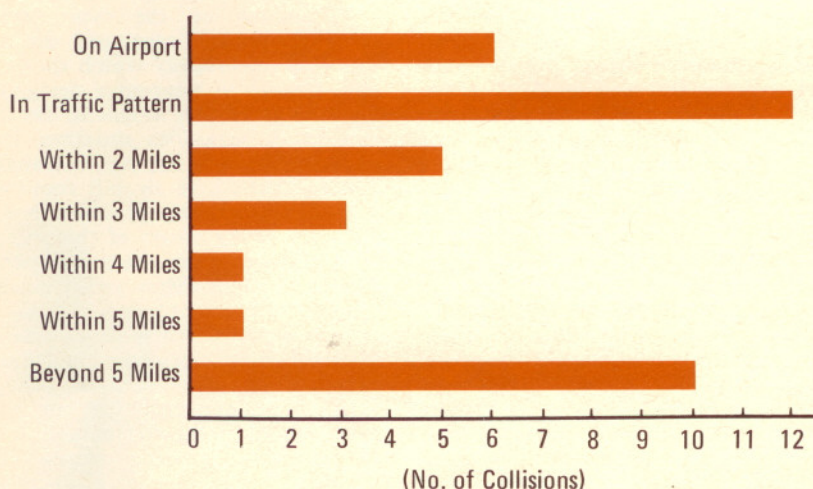
1968 MIDAIR COLLISIONS

(PROXIMITY TO AIRPORT)

Summarizing part of its conclusions, the Safety Board said, "It was noted that two of every three collisions occurred at an airport, that the pattern of collisions started during the descent to the airport, that it gradually increased while entering the landing pattern, and that the most critical period is the final turn-in right up to the airport threshold

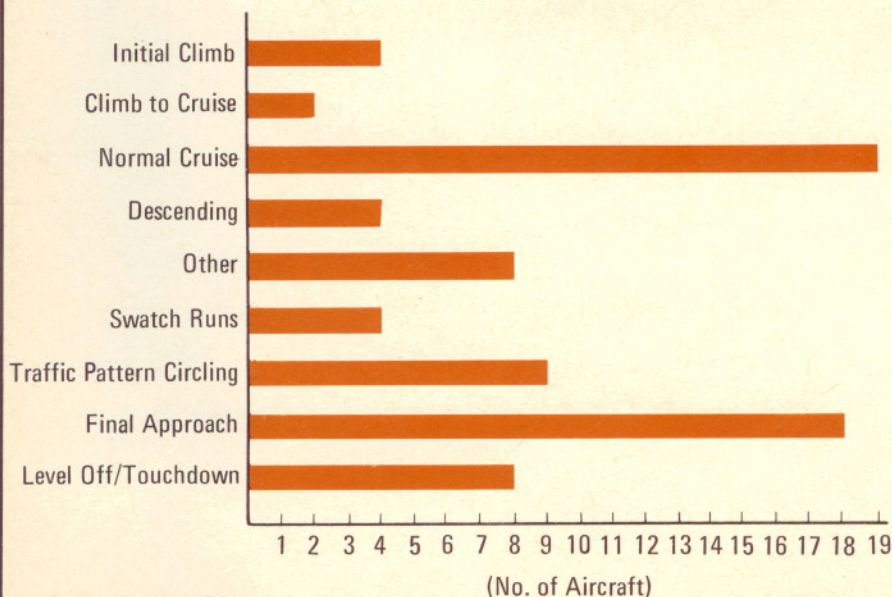
FLIGHT PHASES OF MIDAIR ACCIDENTS

(38 Mishaps, 76 Aircraft)

and flare-out. It is during this critical period that four of every five collisions at or near airports occurred."

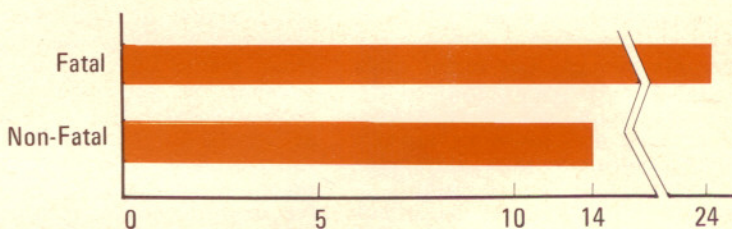
1968 FATAL AND NON-FATAL MIDAIR COLLISIONS

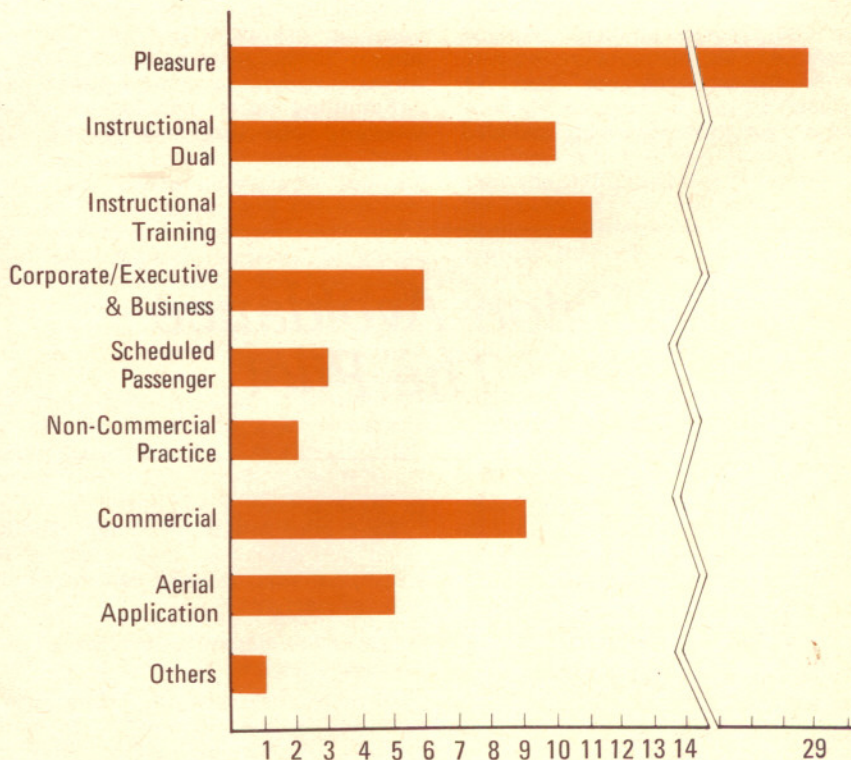
TYPE OF FLYING IN MIDAIR COLLISIONS

(38 Mishaps, 76 Aircraft)
