BONANZA BESIEGED

*An attempt to put
the controversy
into perspective.*

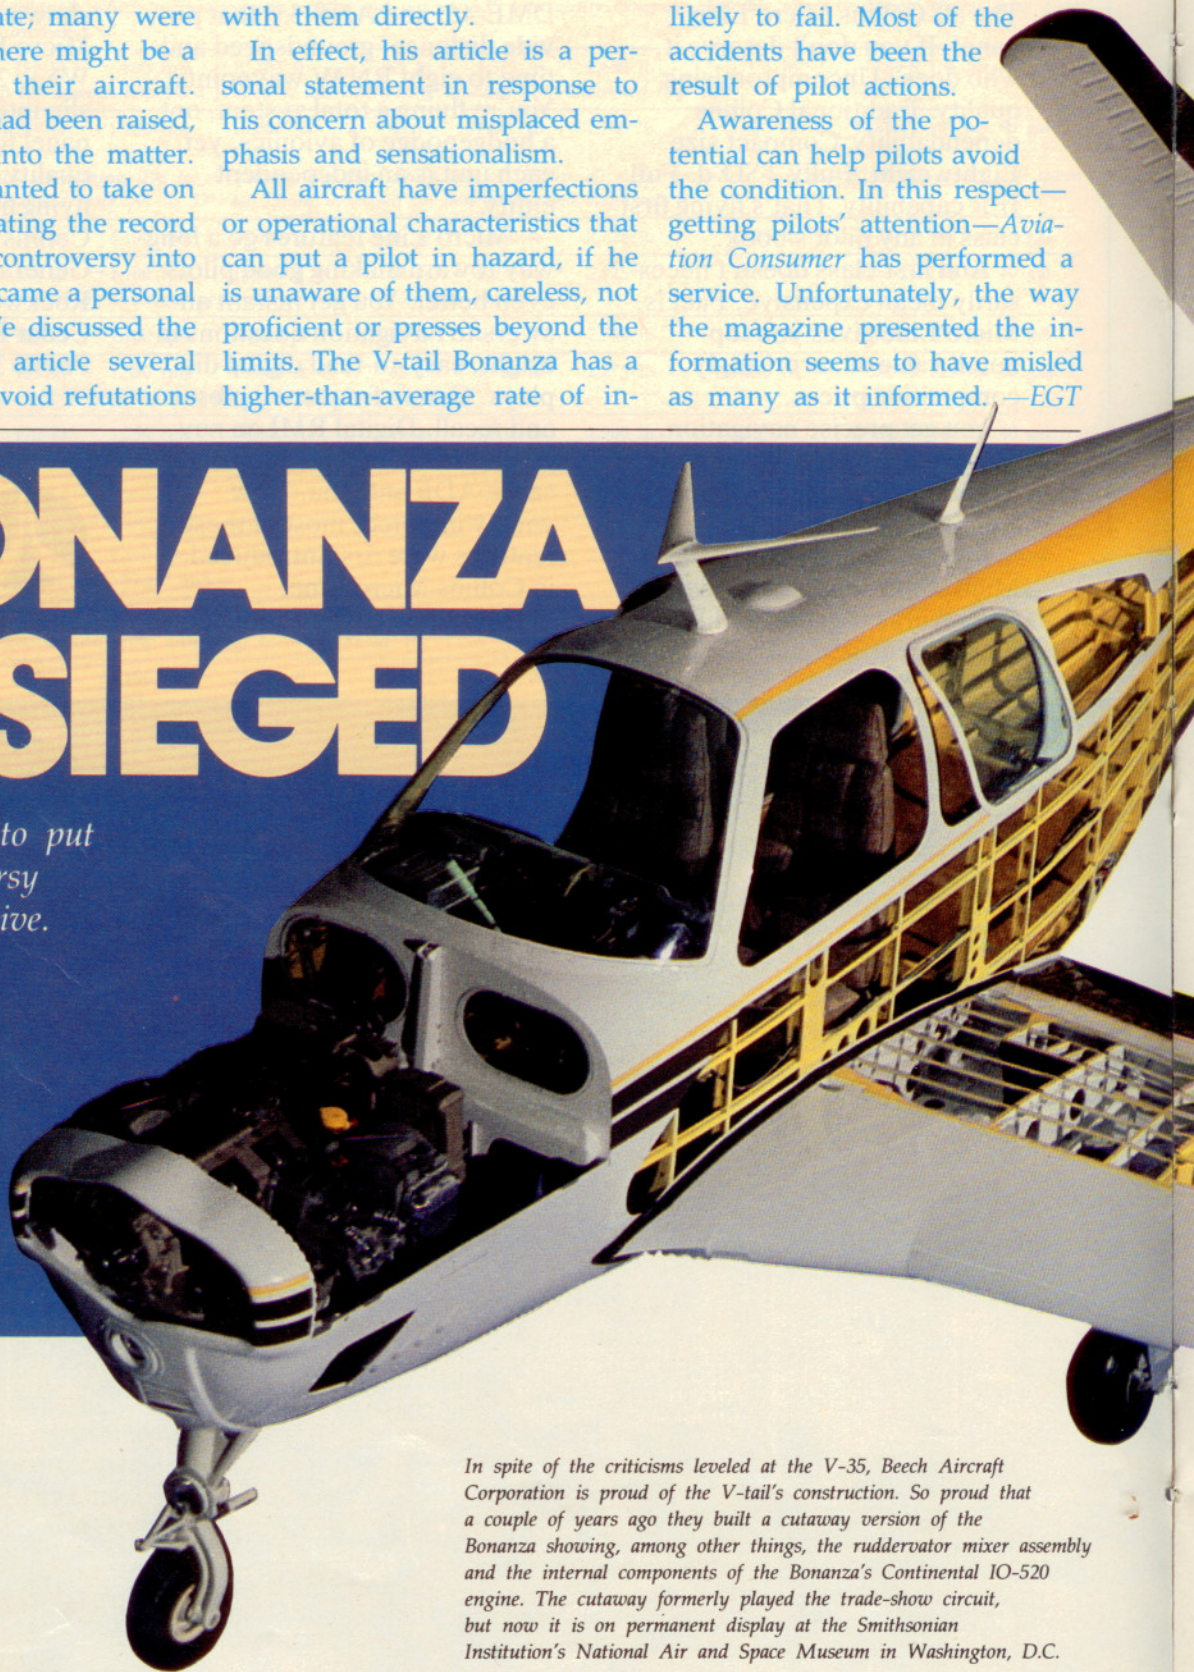
In spite of the criticisms leveled at the V-35, Beech Aircraft Corporation is proud of the V-tail's construction. So proud that a couple of years ago they built a cutaway version of the Bonanza showing, among other things, the ruddervator mixer assembly and the internal components of the Bonanza's Continental IO-520 engine. The cutaway formerly played the trade-show circuit, but now it is on permanent display at the Smithsonian Institution's National Air and Space Museum in Washington, D.C.
