YESTERDAY'S WINGS TODAY

BELLANCA VIKING

B *High performance in a 50-year-old design*

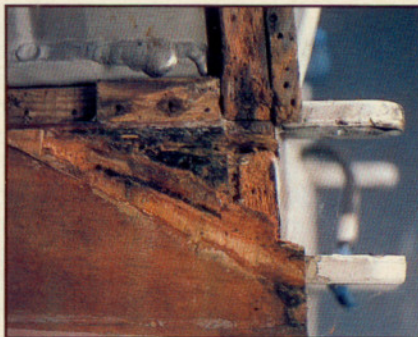
Front seat rail obstructs landing gear pump, complicating service and maintenance (left). Aluminum corrosion is not a concern with a Viking wood spar; decay-producing fungi is (right).

Service difficulty reports from 1980 through September 1985 contain numerous accounts of Viking landing gear problems. There are several reports of gear malfunctions caused by cracked or broken welds and leaks or low fluid levels in the electrically actuated hydraulic system. It is a tedious, time-consuming job to service the gear pump, which is mounted just below one of the right front seat rails.

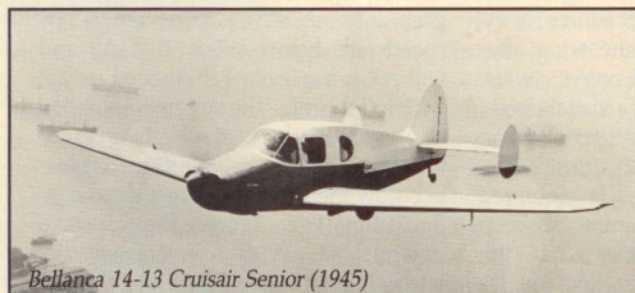
Bellanca 14-13 Cruisair Senior (1945)

The 14-9 Crusair, certificated in 1939, was the patriarch of the series that evolved into the Viking. The number "14" in the model designation stood for the Crusair's 140-square-foot wing area, while "9" represented 90 horsepower. A later postwar version of the Crusair, the 14-13, was powered by a 150-hp Franklin flat-six engine and had 161 square feet of wing.

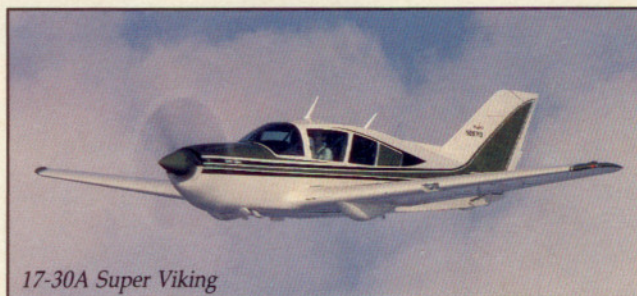
17-30A Super Viking

The Viking underwent an aerodynamic cleanup for the 1979 model year. The nosewheel retracts fully and is enclosed by gear doors, but only on the Continental-powered 17-30A. Wing tip lights are flush-mounted, and the flashing beacon is replaced by strobes. The changes added about 10 knots to the Viking's cruise speed. All Vikings built since then are identical to the 1979 model.
