Used Aircraft Report:

The "Straight 35" Bonanza

by DON DOWNIE / AOPA 188441

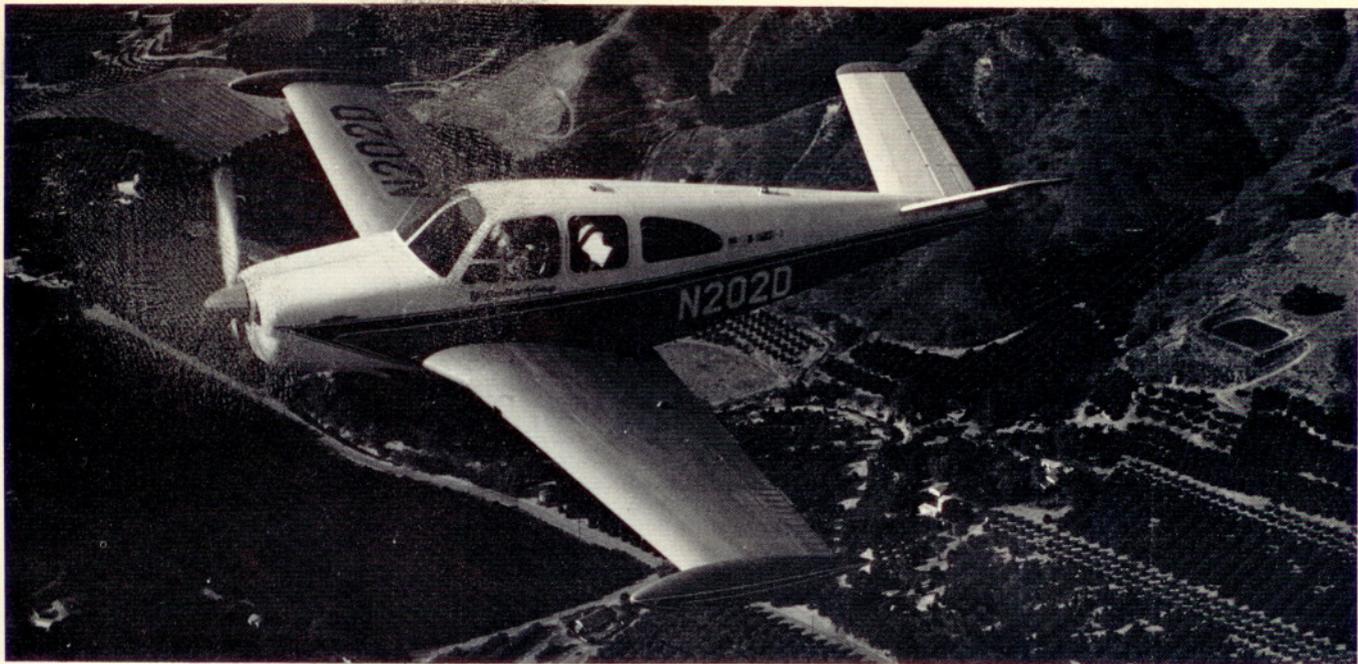
Many original Bonanzas have been modified and modernized by their owners. The one flown by the PILOT was no exception, with added third window, tip tanks—and a full paint job. Original stall warning vane remains on top of the left wing, just forward of the flap.

Outside, the airplane looked good. Small tip tanks and a full paint job showed a minimum of hangar rash. Originally, the Model 35 came out with no paint, and many owners of this vintage airplane have maintained them in mint, mirror-clean condition. Ample cowling access doors opened to show the clean, 225-hp Continental that was standard in 1954-56 units.

It was a subtle pleasure to feel the light, responsive controls. Rate of roll was excellent and the tip tanks seemed to cut down on the original yawing tendency of the V-tail. Installation of tip tanks, 12-gallon "flight extenders," also tended to increase spiral stability, an item found wanting by many early Bonanza pilots. Later models carried a 20-gallon Brittain tank.

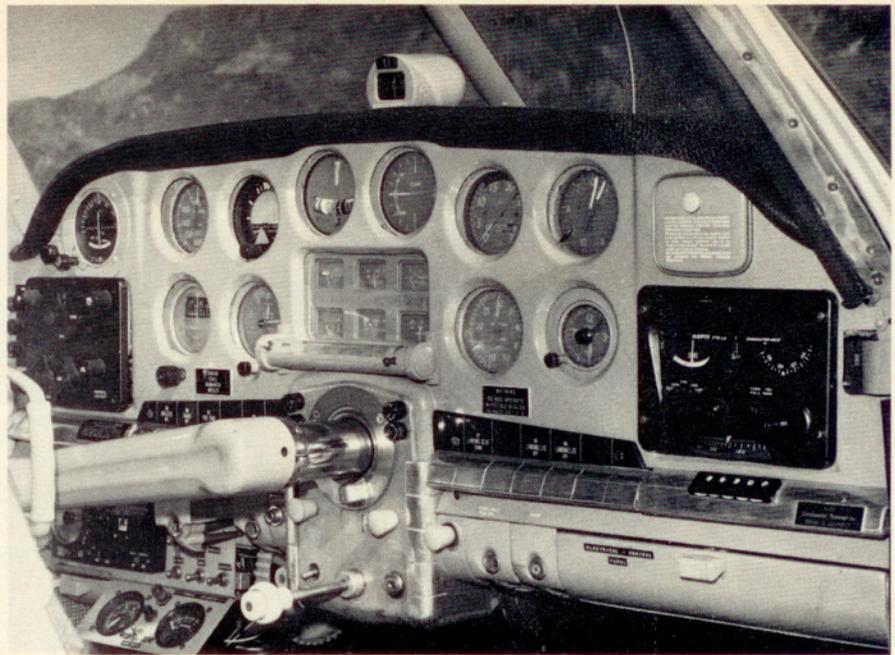
The panel of N202D belies the airplane's age, with older-style instruments spread about the panel and radios unfamiliar to many of today's pilots. That's a Narco Omnigator navcom on the right and a large King KX-100 navcom on the left with an also bulky King ADF just visible below it.

Mike Dewey (AOPA 225296), who heads Screaming Eagle, checked the keys and the paperwork before we pulled N202D into the California sunshine. Much of this airplane was original. The instrument panel was gray with gauges hard to read by today's standards. The Beech electric prop had well-preserved wooden blades. Seats were neither reclining nor adjustable. The stall warner was a vane in the airflow near the trailing edge of the left wing inboard of the aileron point. Avionics included a venerable Narco Omnigator, the bulky King KX-100 primary nav/com set and a large King ADF slung below the left side of the panel close to the pilot's knee.
