UNDER A CLOUD

*A series of accidents
raises serious questions
about the Piper Malibu.*

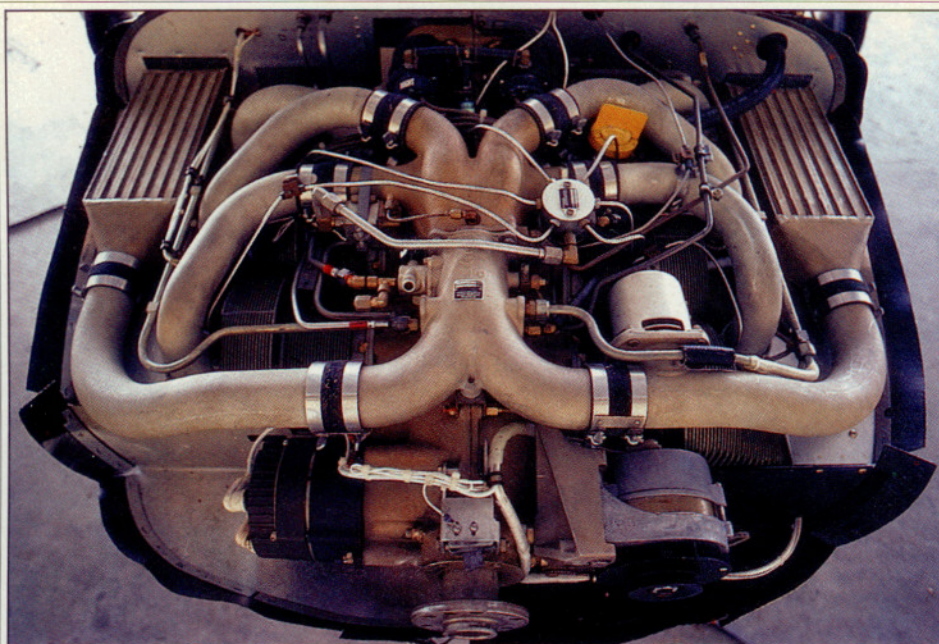
Piper and Continental have sparred over problems with the TSIO-520 engine in the Malibu. The twin turbocharged and intercooled powerplant is operated lean of peak at cruise.

lems concerned the Continental engine, in particular, fretting of the crankcase at the main bearing support and shifting of the bearings. Piper's relationship with Continental became increasingly strained as the two companies sparred over engine problems. At one point Millar took the extraordinary step of contacting Malibu owners to ask them to stop flying their airplanes until a problem was corrected. To atone for the inconvenience, Millar bought first-class airline tickets for Malibu owners who had to make business trips.

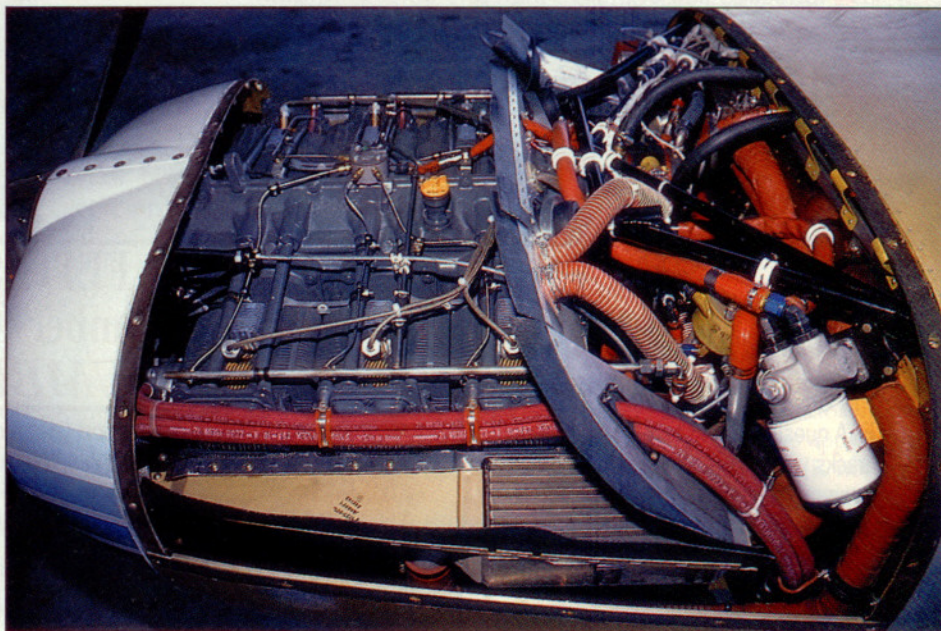
The Mirage, which replaced the Continental-powered Malibu, has a 350-hp Lycoming TIO-540 in the nose. The extra power boosts cruise speed at the expense of fuel flow.

In 1989 Piper switched to a Lycoming

engine for the Malibu and in the process adopted the name Mirage. Dual 70-amp alternators and dual continuously driven vacuum pumps were included as standard equipment on the Mirage. The interior also received a facelift. Even at \$359,000 for the basic airplane (the price for a new Mirage equipped with color radar and electronic flight instruments topped \$550,000), orders flowed in and the backlog grew.

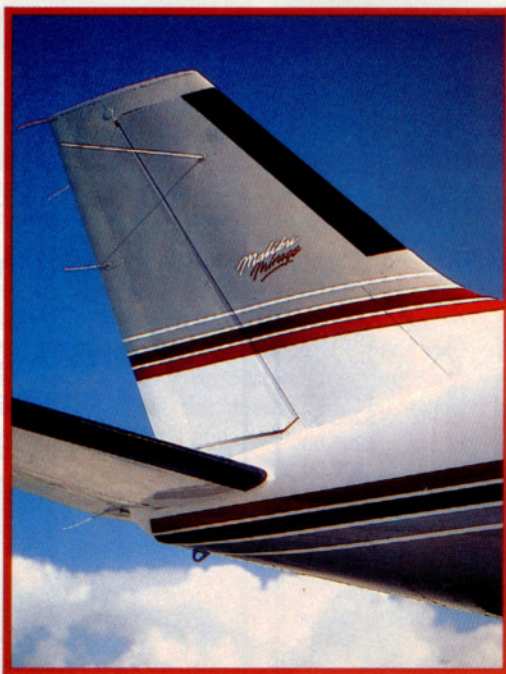
Light controls are delightful in visual conditions, but less desirable in the clouds.

Where the P210N edges the Malibu is in handling qualities in turbulence and in the clouds. The Malibu's long wing is an advantage in climb and cruise, but it does not take the bumps as well as the P210N's shorter-span, wider-chord wing. The Malibu has lighter pitch forces than the P210N ("truck-like" is often used to describe the Cessna's handling) and also is less stable in yaw. Light control feel is a delightful characteristic when hand-flying in visual conditions, but less desirable in turbulent air or when the view out the windows is of the inside of clouds. The P210N has not been immune to airframe failures, especially early in the program when it was beset by vacuum system troubles and in thunderstorms. It was also once the subject of an AD restricting operation in IMC, but with modifications the airplane could be immediately returned to full service.
