# PIPER MALIBU/MIRAGE

## BACK FROM THE EDGE

### *The FAA looks for trouble.*

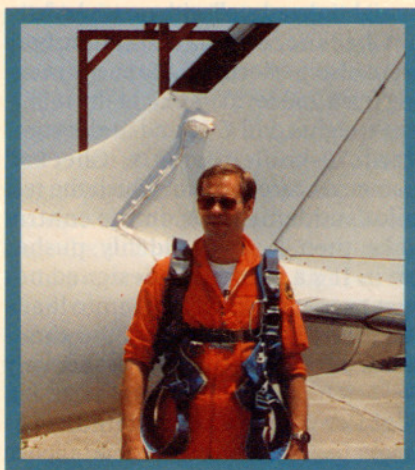
Test pilot David Schwartz with N9135D. Air data computers (below, left and right) kept track of each test, while the stabilizer's reference lines revealed any excessive airloads. Video cameras are on the vertical fin and in the aft cabin.

To document test results, pressure-sensitive "Strip-a-tube" was applied the length of the horizontal tail's chord; this recorded pressure distribution over the tail. Strain gauges were installed to measure aerodynamic stresses electronically. Potentiometers, installed at the end of the elevator push rod, gave precise readings of control deflections. Finally, two video cameras were aimed at the tail surfaces—one in the cabin, aiming rearward, and one on the vertical fin, looking down.
