Budget Buys

Tribal chief

Comanche 250: The most popular of Piper's Indians

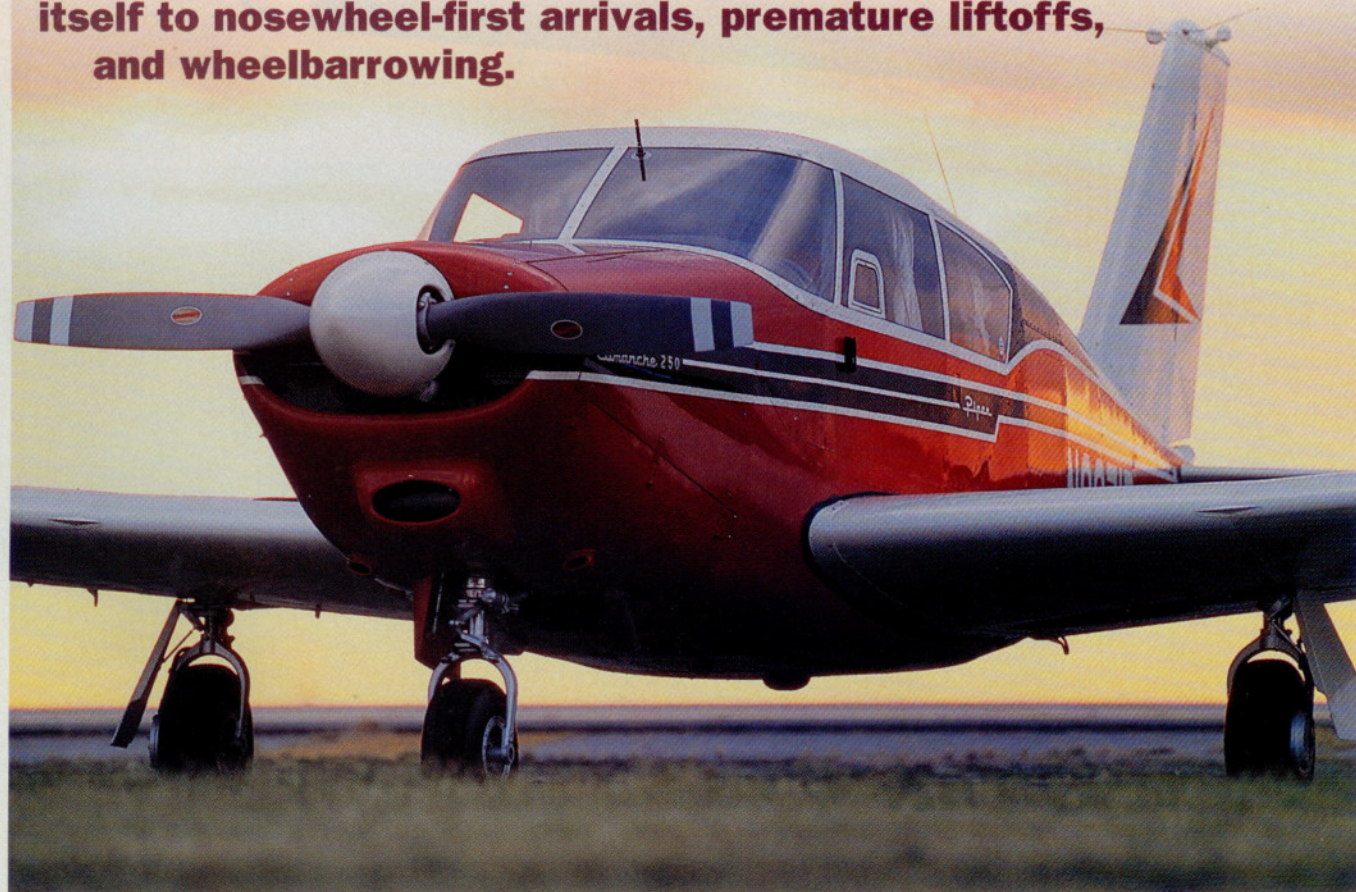
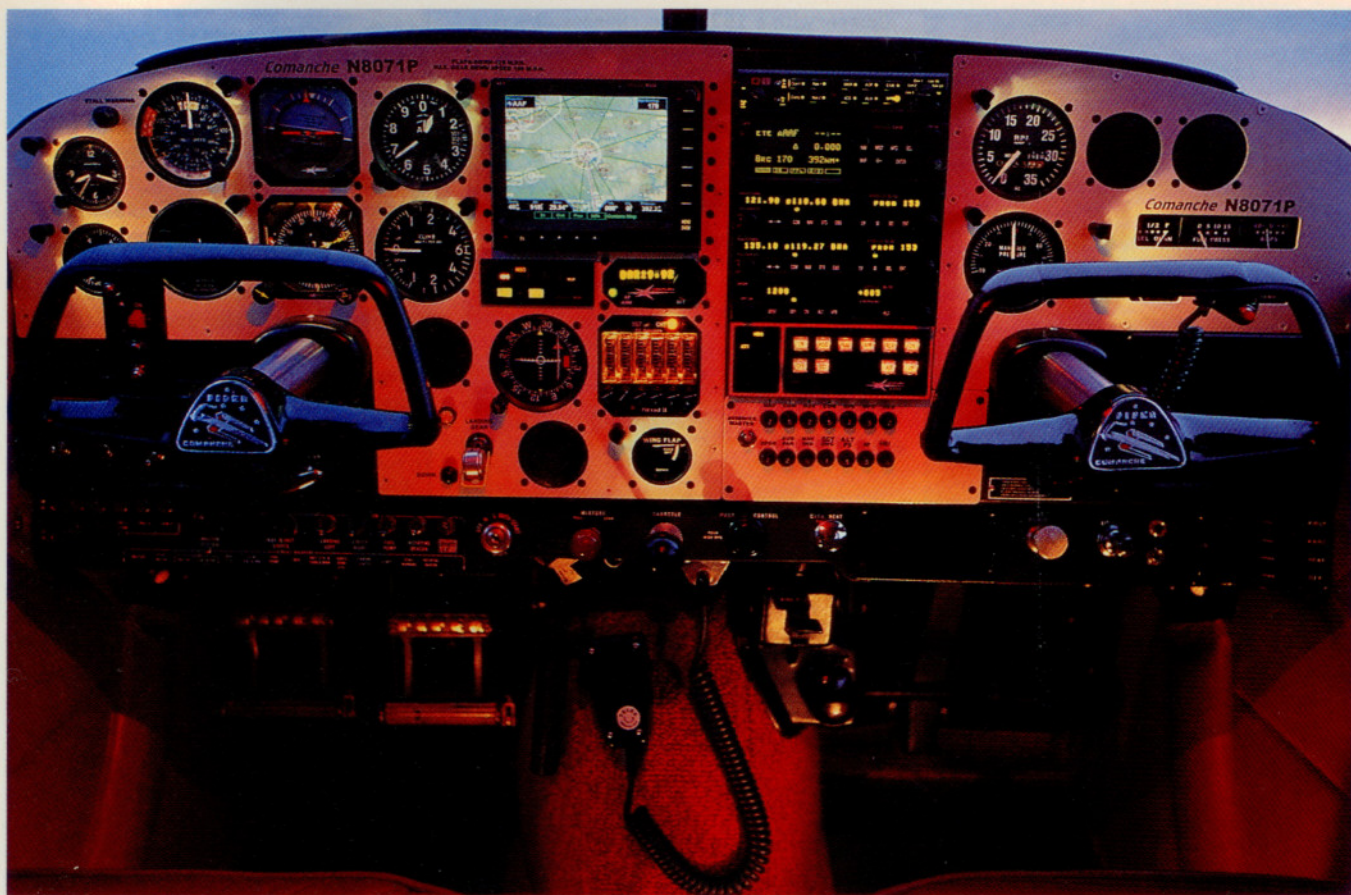
This pristine Comanche 250 is a blend of old and new. Original instruments merge with a full UPS Aviation Technologies stack, a Century 2000 autopilot, and much more. The trademark Piper control yoke of the 1950s to 1970s—the “square pretzel”—features the Comanche logo, a streamlined bird cruising among the stars.

Then the avionics got a huge upgrade. Out went the vintage Narco Mark V nav/com. In went a UPS Aviation Technologies suite: a GX50 GPS receiver, an MX20 multifunction display unit,

and two SL30 nav/coms. A Century 2000 autopilot and altitude alerter were also added. Now this rare airplane is a strong blend of the old and new. Photographs of Totty and Simmons' airplane accompany this article, and prove this 250's prize-winning status.

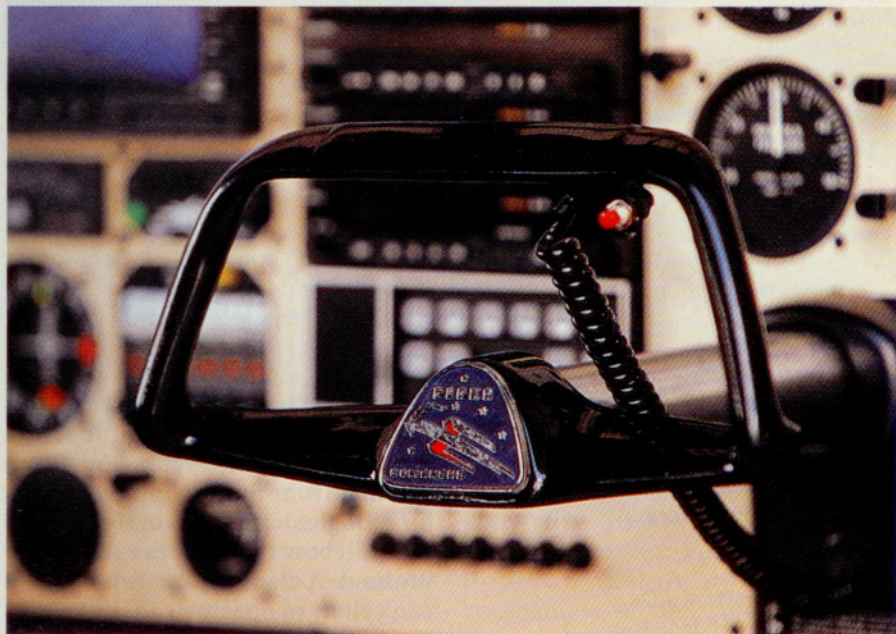
After an emergency gear extension, there is no positive downlock for the

landing gear. The overcenter movement of the gear's drag links, the pull of bungee cords, and the nose-gear springs are the only forces holding the gear down.

To help prevent the gear from collapsing, landing-gear bushings must be inspected every 1,000 hours for excessive wear. Bungees must be inspected, and replaced if necessary, annually and

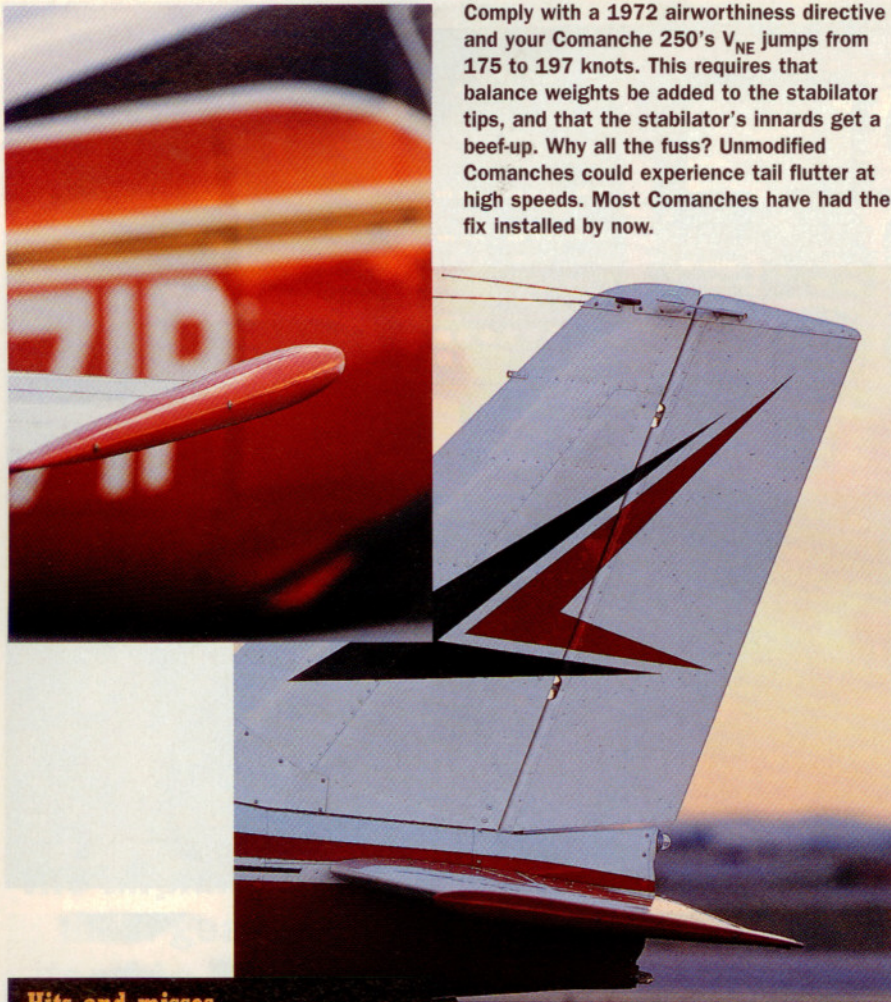
Comply with a 1972 airworthiness directive and your Comanche 250's V_{NE} jumps from 175 to 197 knots. This requires that balance weights be added to the stabilator tips, and that the stabilator's innards get a beef-up. Why all the fuss? Unmodified Comanches could experience tail flutter at high speeds. Most Comanches have had the fix installed by now.

- Airframe. AD 72-22-05 addresses tail flutter issues in Comanche 250s. Comply with it and a 202-mph/175-kt V_{NE} restriction is raised to 227 mph/197 kt. Compliance involves adding balance weights to the stabilator tips and strengthening the internal stabilator structure.

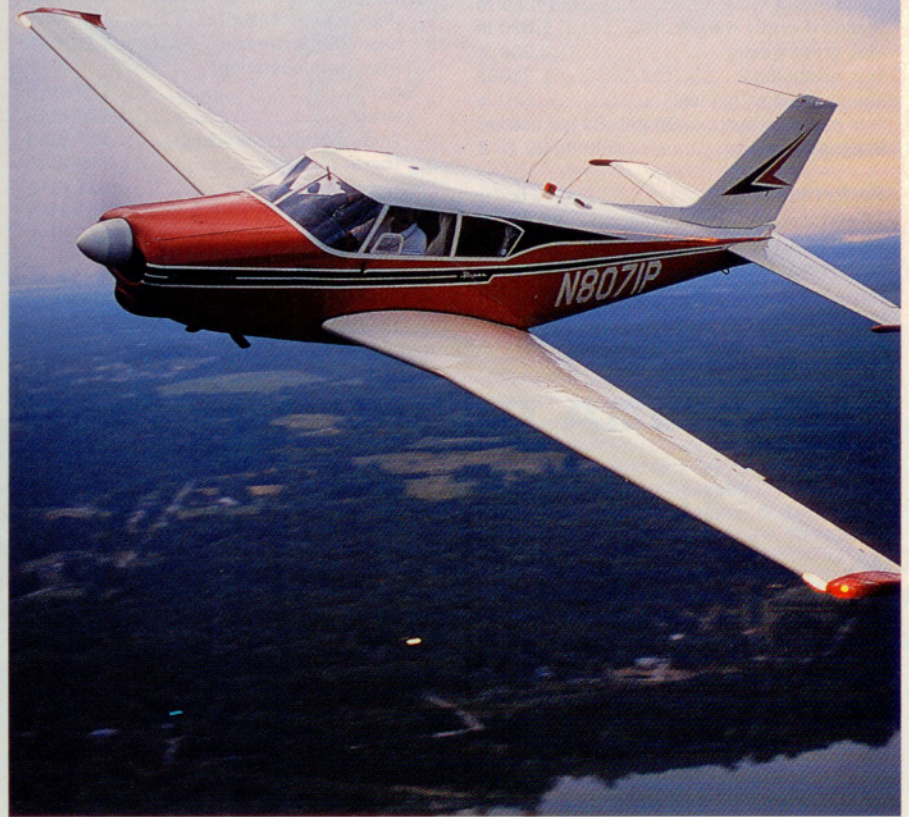
The protection offered by the dry desert air preserved the airplane in like-new condition. The “Palm Beach” interior and paint scheme are original, right down to the side window curtains and red leather seats.

The protection offered by the hangar and the dry desert air preserved the air-

plane in like-new condition. The “Palm Beach” interior and paint scheme are original, right down to the side window curtains and red leather seats. Totty, an aircraft broker and A&P mechanic, gave the engine new cylinders, fuel pumps, magnetos, and Lord mounts; overhauled the carburetor; and installed a smaller nosewheel (a modification designed to prevent wheelbarrowing). Inspections of the airframe revealed no corrosion.
