Paint—protection and pride

The airplane formerly known as N14422

BY STEVEN W. ELLS

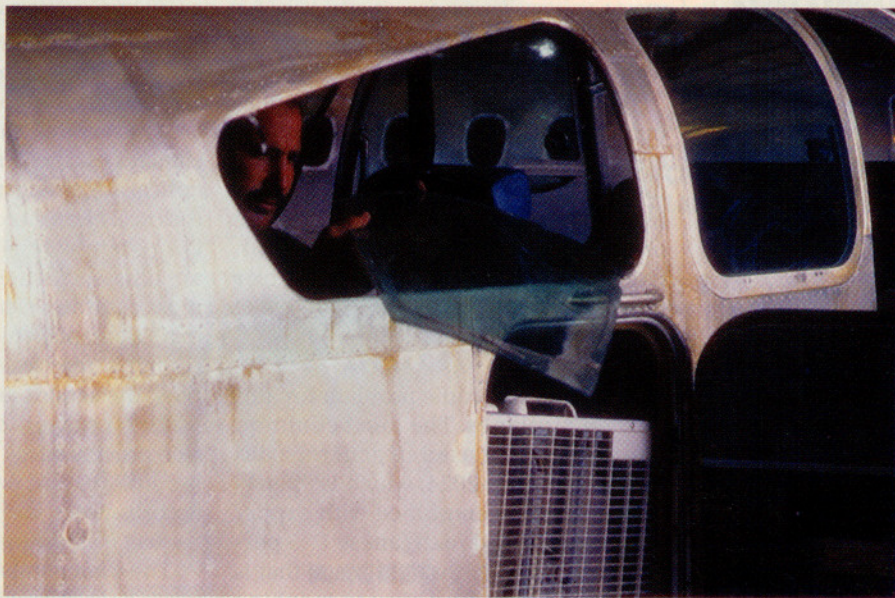
Stripped and masked for painting, the AOPA Sweepstakes Bonanza sits in front of Murmer Aircraft Services in Arcola, Texas (above). A fan keeps Doug Kelly cool while he's installing the new Beryl D'Shannon windows (left).

The three-eighths-inch-thick Speed Sloped windshield installation added a smoother, more streamlined look that helped to modernize our Bonanza. Both of the three-eighths-

inch-thick pilot and copilot side windows have inward-opening vents—and these vents are frameless, so visibility is better and the cabin feels more open, a marked improvement over the original pilot's vent window. Aileron and flap gap seals prevent air bleed-through around the control surfaces. This improves slow-speed handling, as well as reduces drag. Lower drag equals faster cruise, and better climb rates.

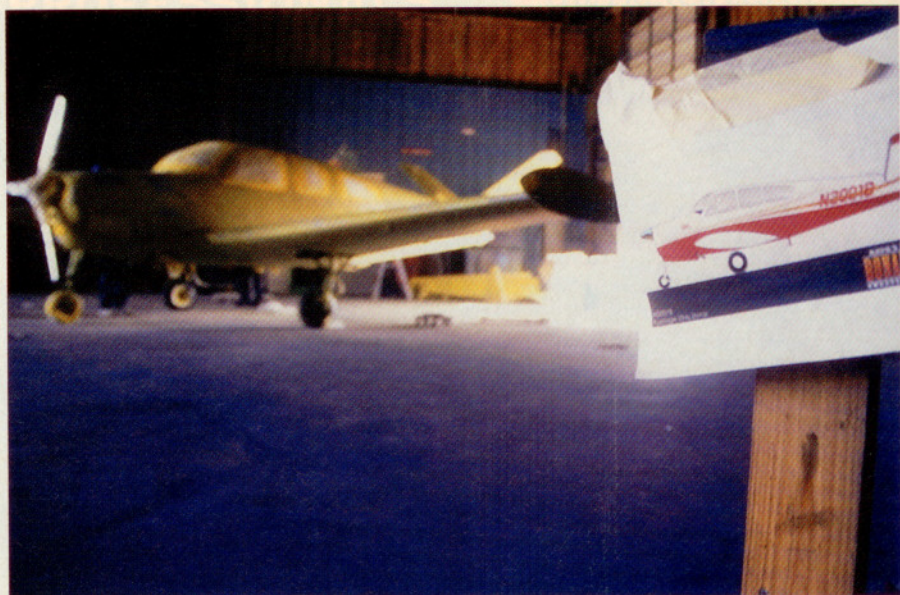
A diagram from Scheme Designers is ready to guide painters in applying the sweepstakes Bonanza's new colors.

Every step of the way Barnett presented a menu of options—after six review-and-suggestion sessions, spanning a little more than two months, we all agreed on the final design. This process can be followed on the Scheme Designers Web site (www.schemedesigners.com). As with every Scheme Designers layout, Barnett provided a 20-page book of detailed layout and specification drawings to Tolson.

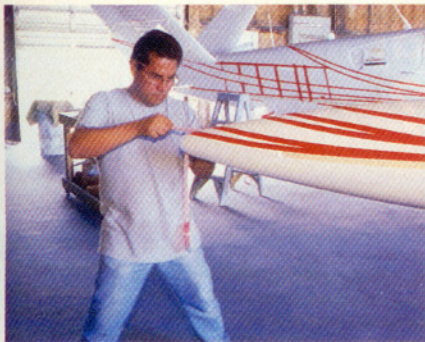
easy-to-spot visual telltale indicating the presence of magnesium corrosion. Tolson spotted paint lifting on the bottom surface of the right ruddervator. After removing the paint only light surface corrosion was found. Although the cleaning and conversion coating prod-

ucts used on magnesium and aluminum differ slightly, the corrosion removal steps and the paint application processes are very similar.

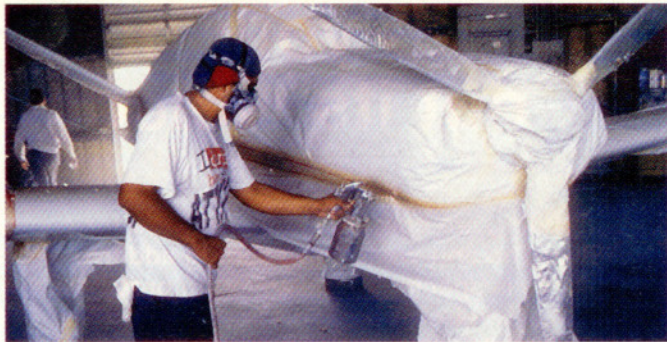
Heriberto Diaz masks striping on the Bonanza's wing tip (far left). Murmer's Lupe Lopez Jr. sprays gold trim over the white base coat (left).

Murmer applies two coats of chromate epoxy primer for maximum adhesion and corrosion protection. After primer application, the finish is again inspected for any possible defects before applying four coats of

Jet Glo polyurethane over the entire airplane (six coats on all leading edges). Then the major accents and trim colors, in Acry Glo urethane, are applied. The result of Murmer's experience in properly preparing and applying a modern paint system to the sweepstakes Bonanza is a long-lasting, wet-looking finish that will protect the integrity of the airframe and boost ownership pride for decades.
